Existing Housing Documentation

ARCHITECTURAL & CONSTRUCTION RESEARCH | EXISTING HOUSING

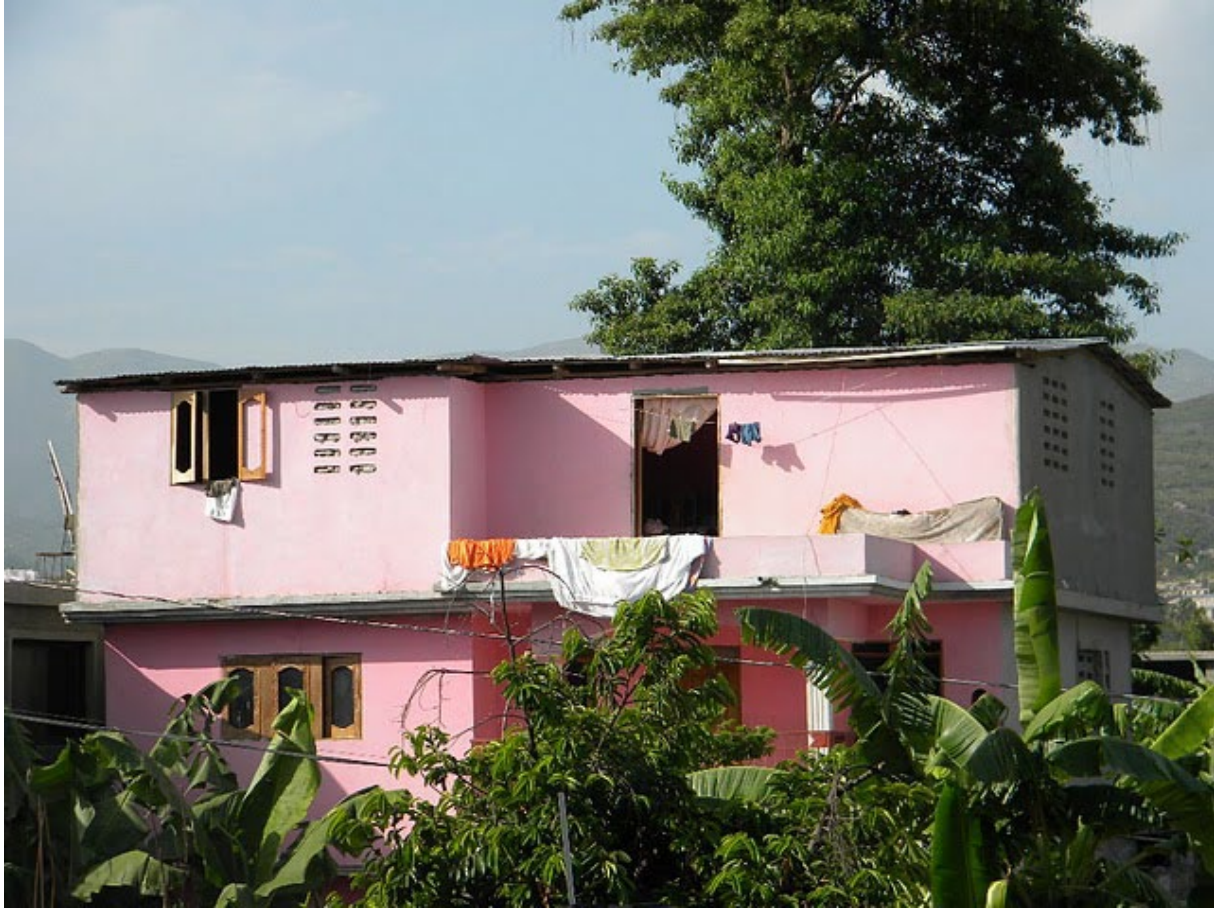
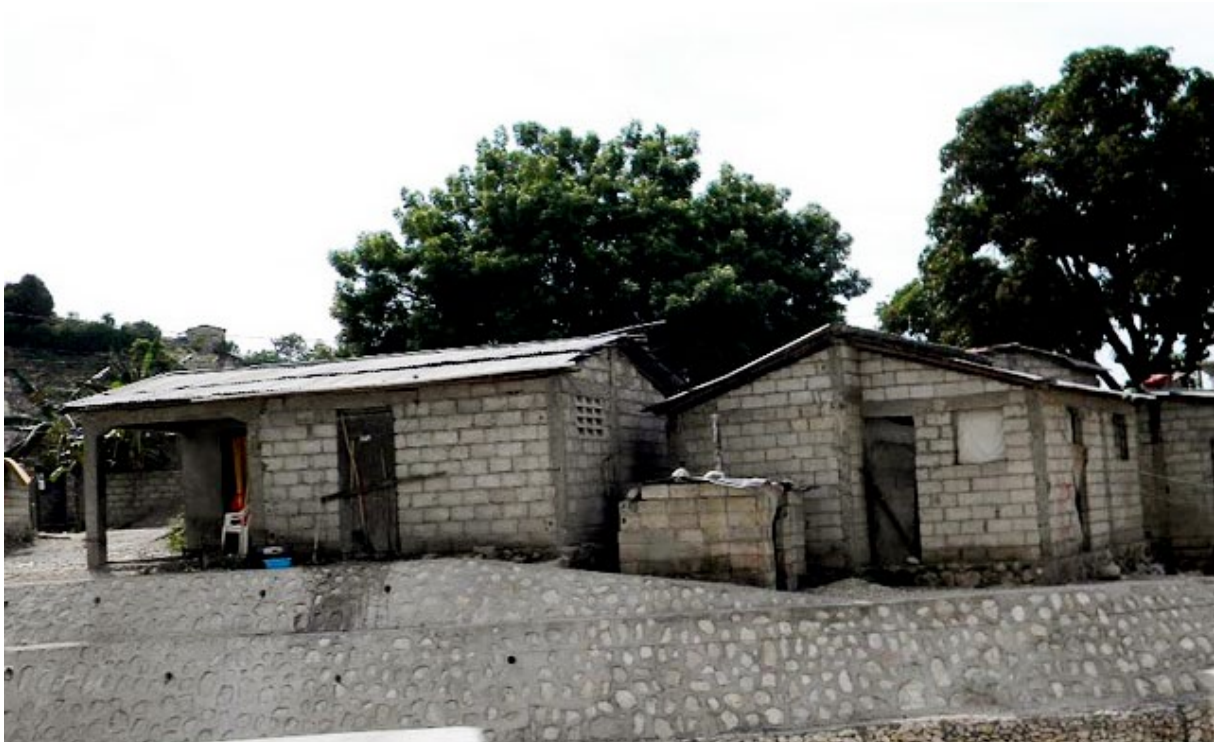
Typical CMU construction with aluminum roofing - however, most houses are finished with some sort of plaster or stucco and painted brightly.

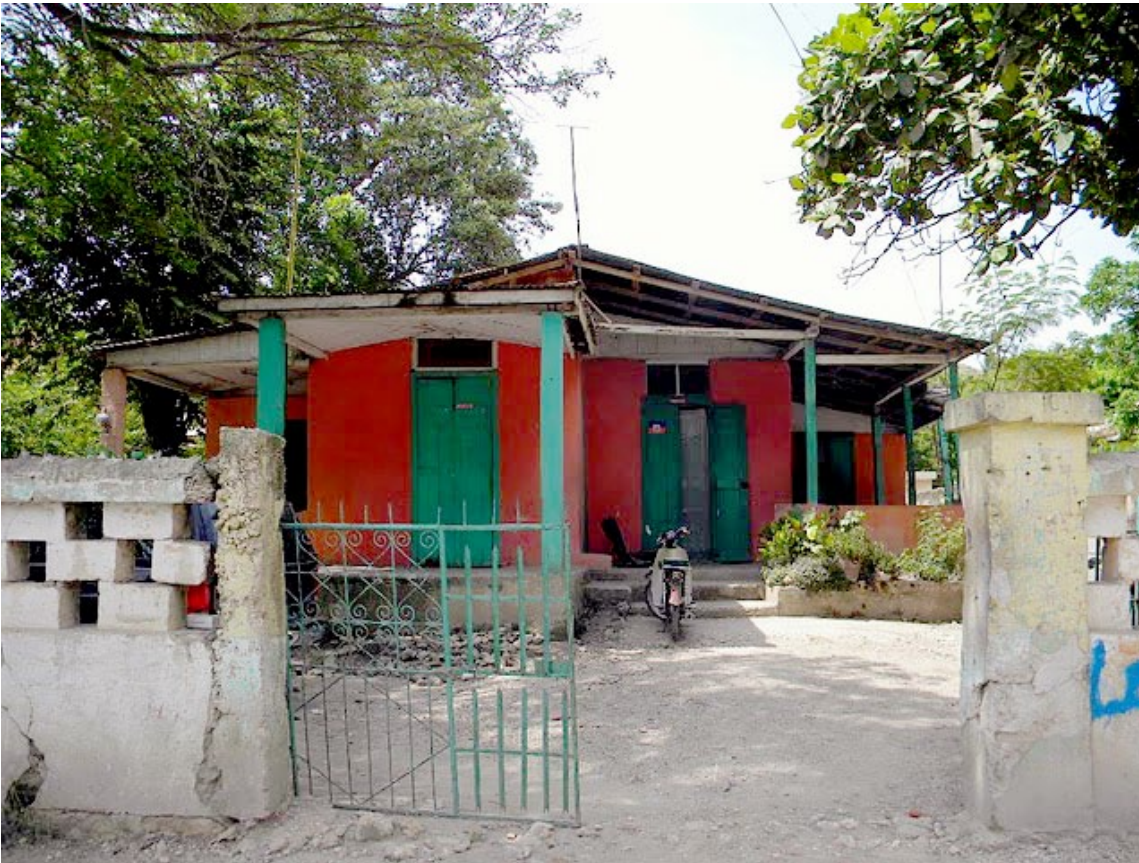
A more “suburban” house (it has a large gated yard and adequate space) in CMU construction with wooden posts and beams and aluminum roof

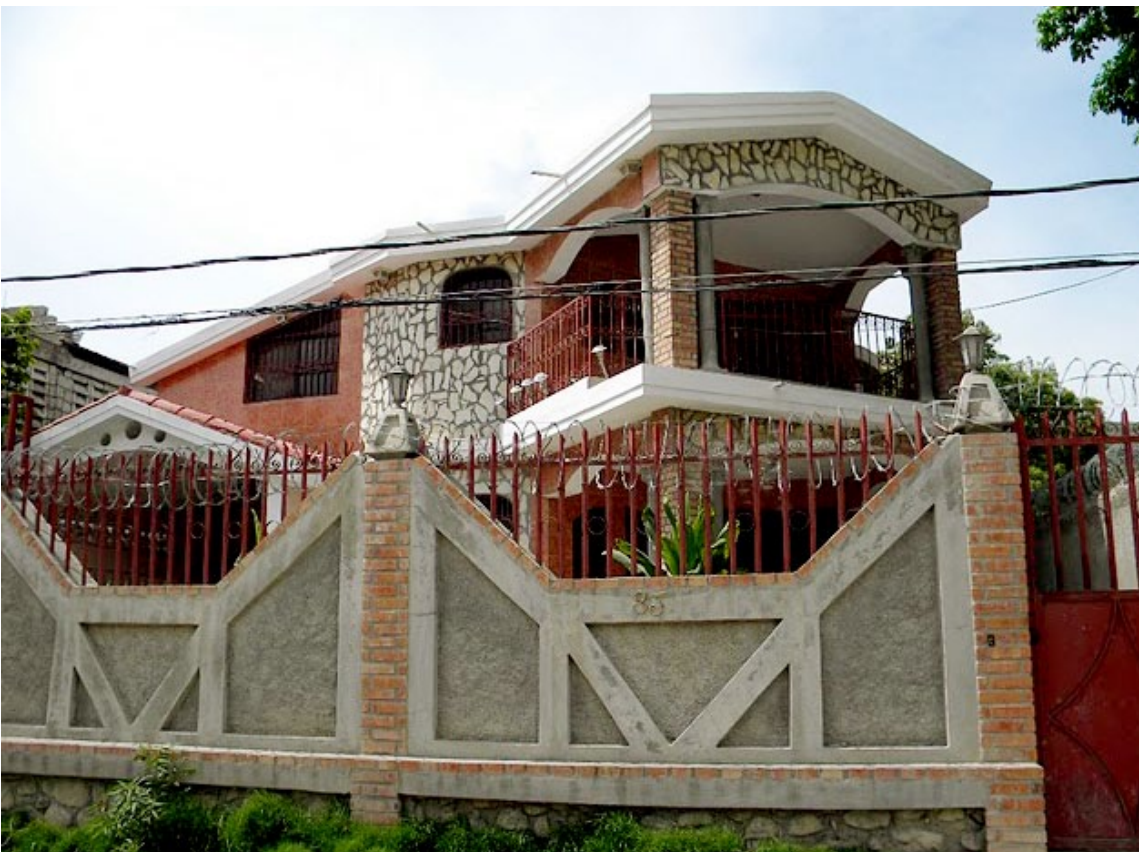
One of the more properly maintained homes in St. Marc - it appears to be of newer construction.

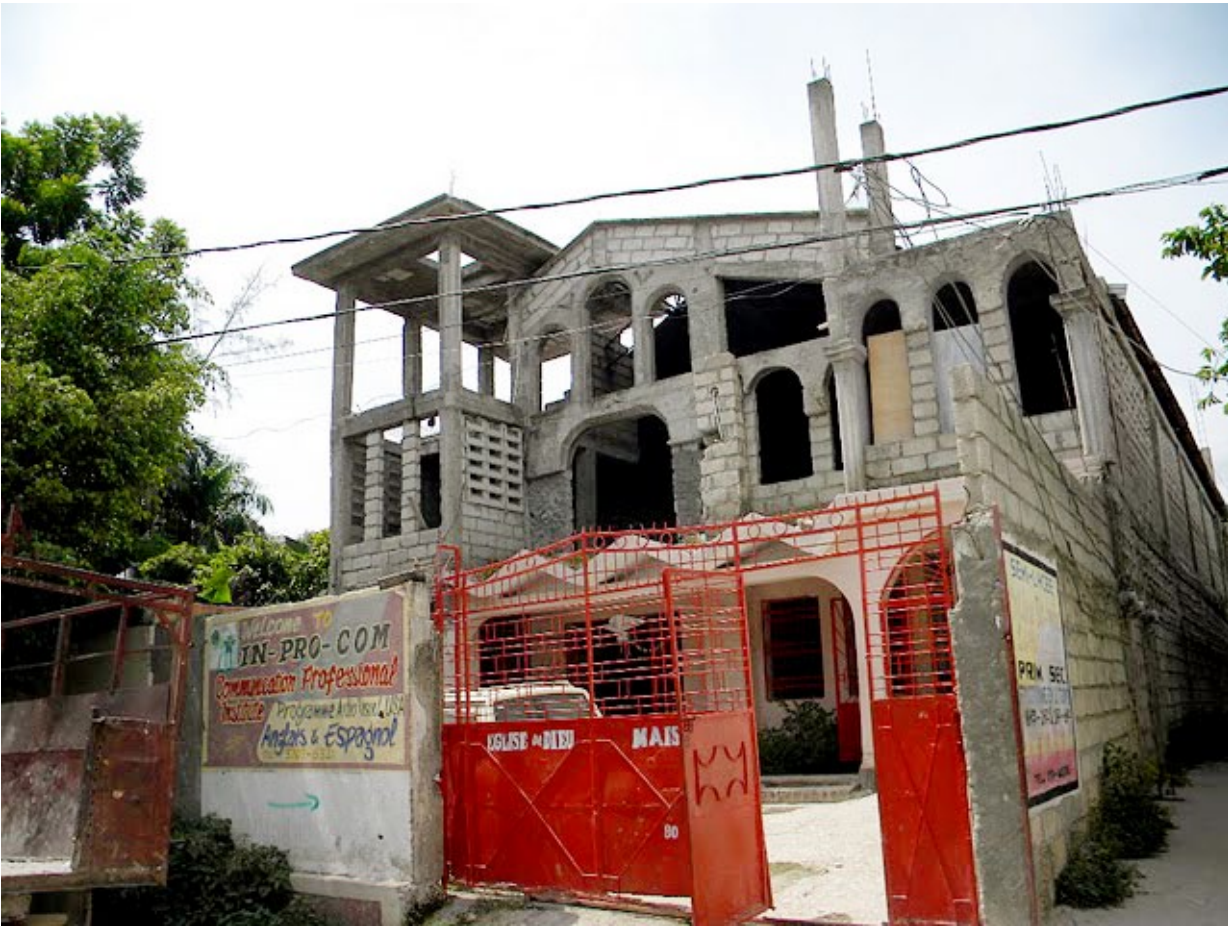
These abandoned houses are everywhere in St. Marc - they were never finished. This provides us with a unique opportunity to see the framework of local construction.

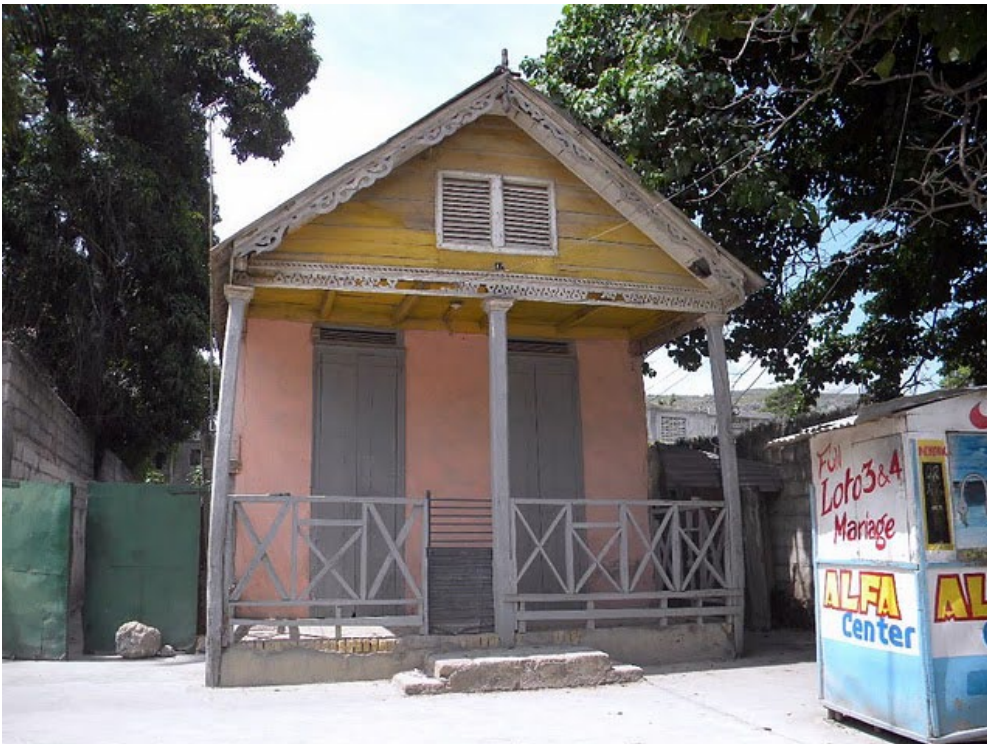
Approaching the center of town - lots are getting smaller. I believe this house is also CMU at core with a wooden attic.

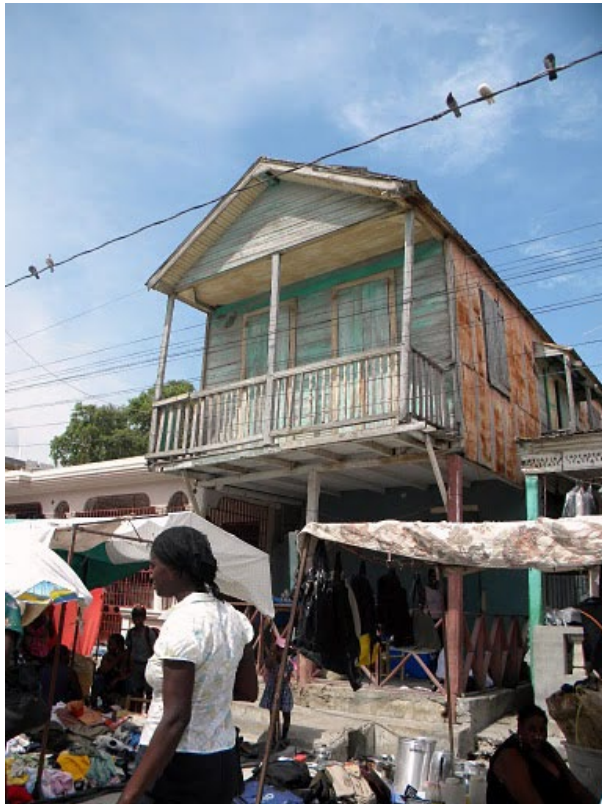
House along the marche (flea market) in the center of St. Marc. Wooden construction.

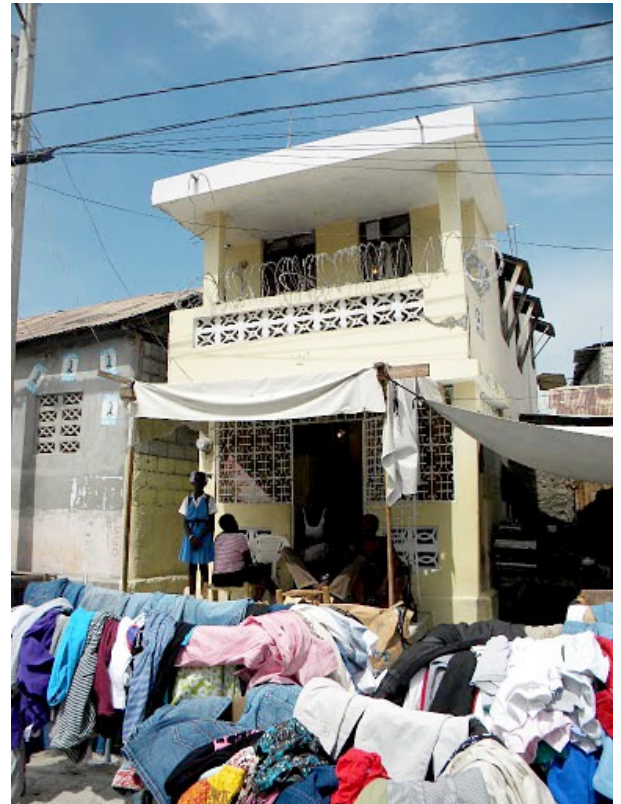
A standard family duplex, CMU construction.

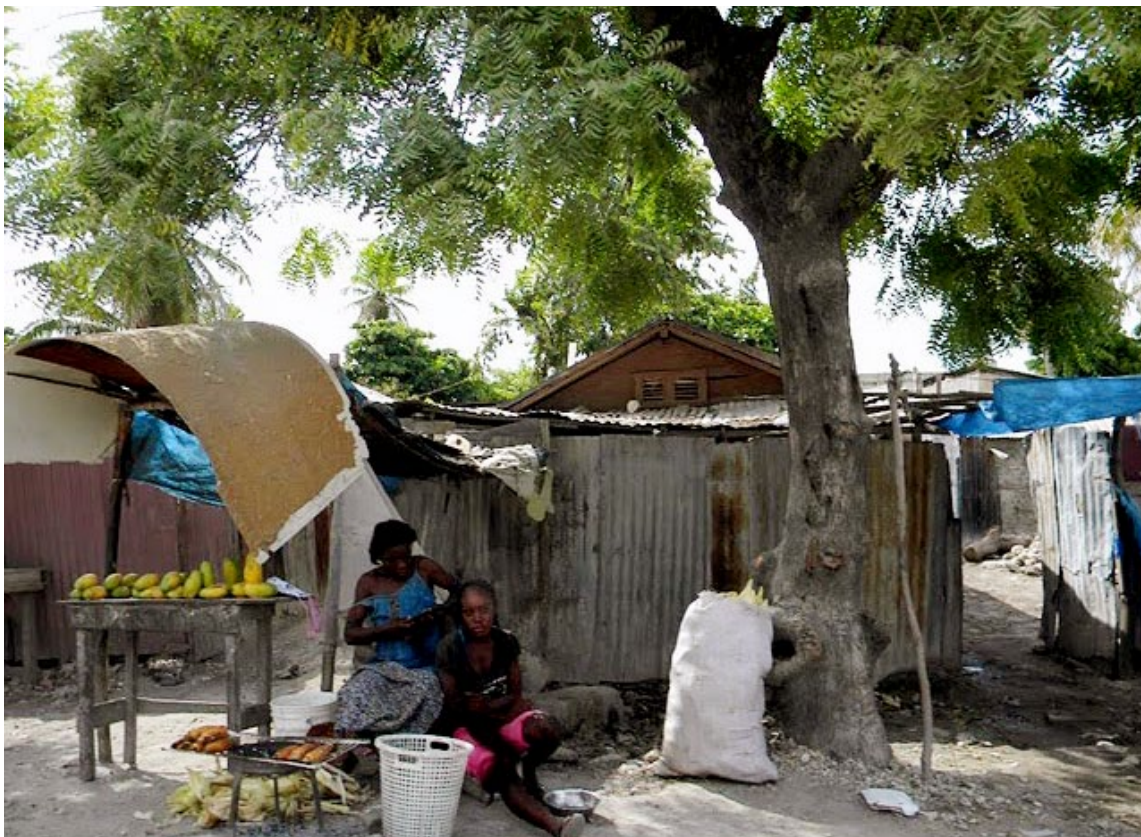
Approaching the outskirts of town, you start to see more “shack-like” dwellings. Pieces of aluminum are attached to wooden sticks for support.

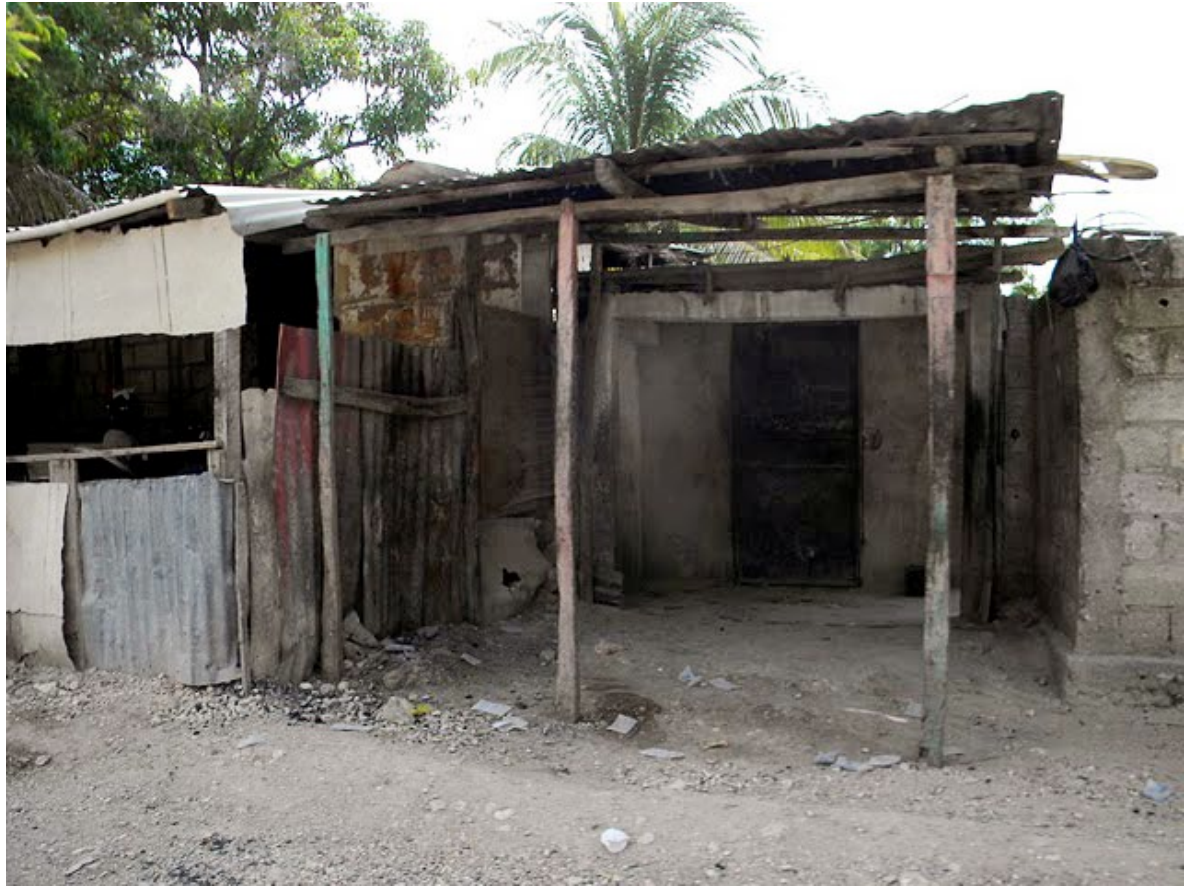
Another “make-shift” dwelling. Note the large outdoor porches, which are often used as cooking/eating areas (you can see this in the house next door). This helps to reduce heat inside the house.

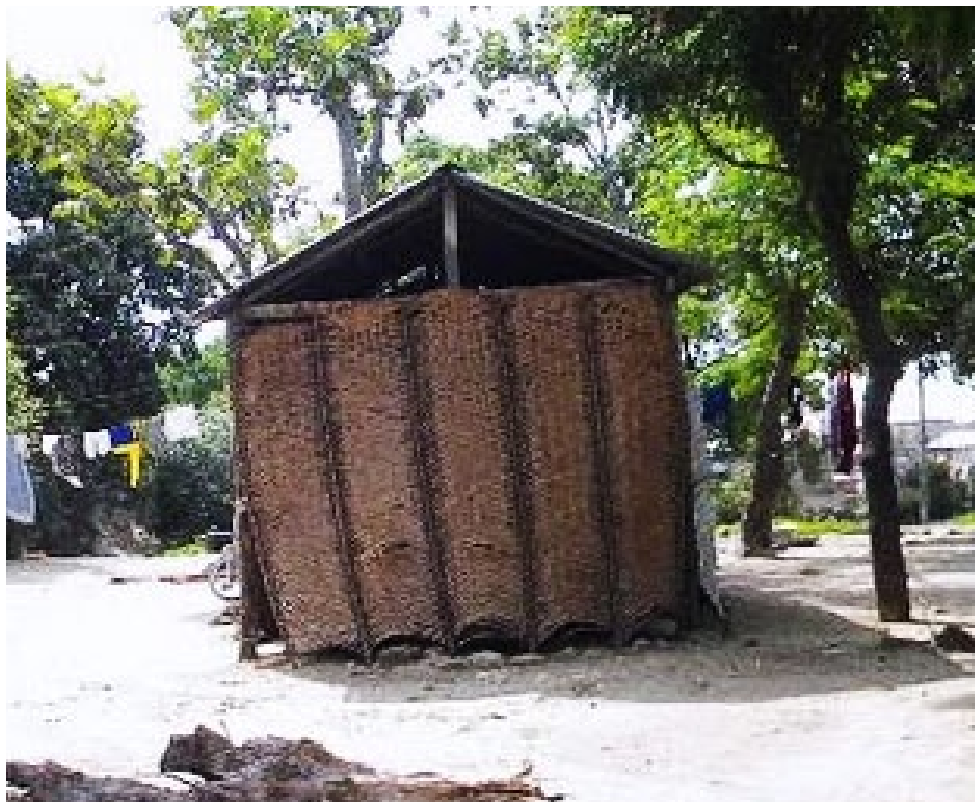
Thatched dwelling. Pieces of thatch are attached to timber for support. Often the thatch starts to mold quickly due to the moisture from the heavy rains.

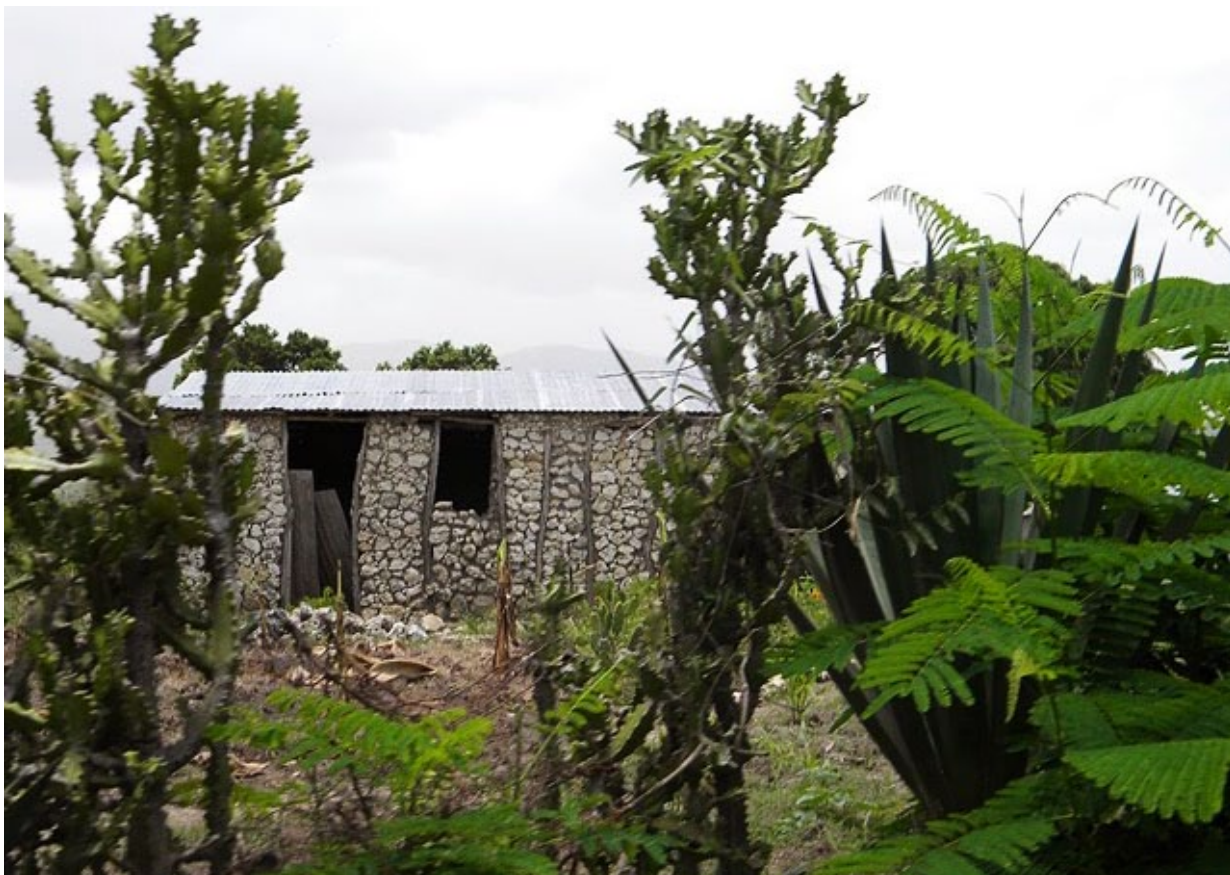
Rural Housing - this dwelling is en-route to the Bois L'Etat site, up in the mountains. Constructed using local rocks found nearby, wood framework, and an aluminum roof.

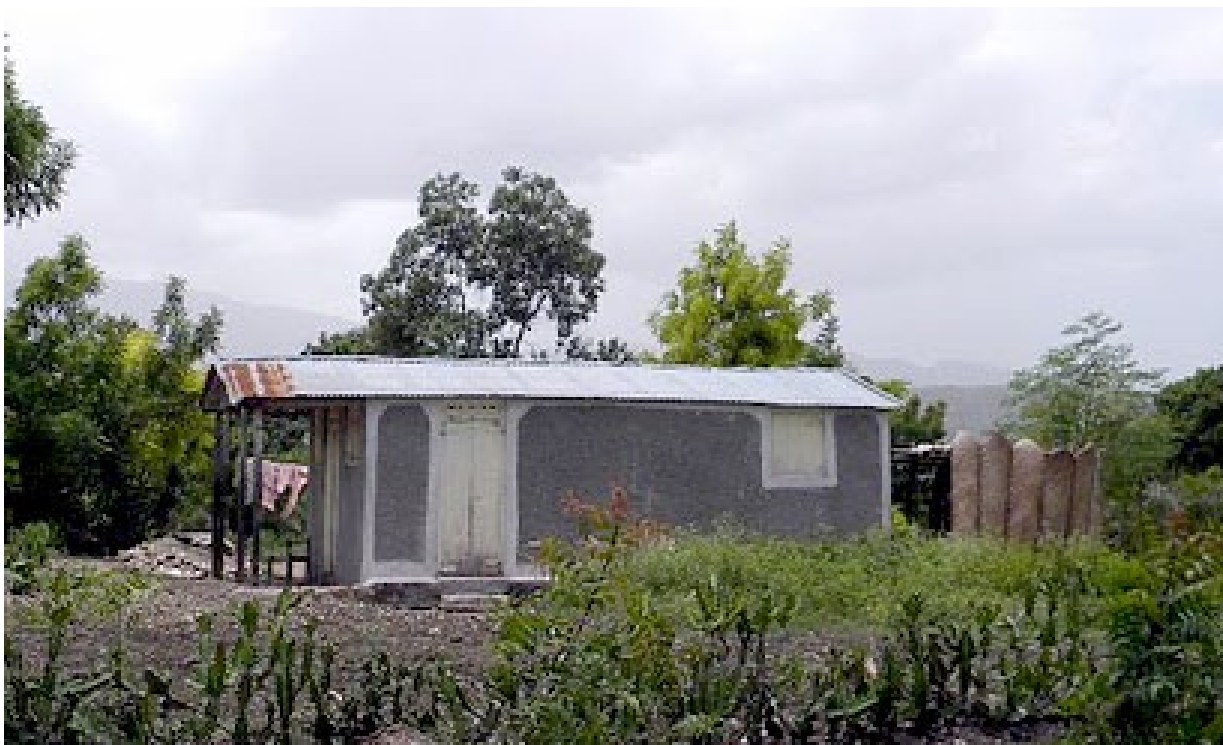
Another rural home en-route to the Bois L'Etat site. Appears to be CMU construction with aluminum roofing.
